6.0 CLIMATE ROOFING SITE - 2700 ISLETA BOULEVARD SW

NMED Facility Number 3245001

Historic Site Map
Climate Roofing Site
2700 Isleta Blvd. SW
Albuquerque, New Mexico

Proposed Borehole and Monitor Well Locations
Climate Roofing Site
2700 Isleta Blvd. SW
Albuquerque, New Mexico

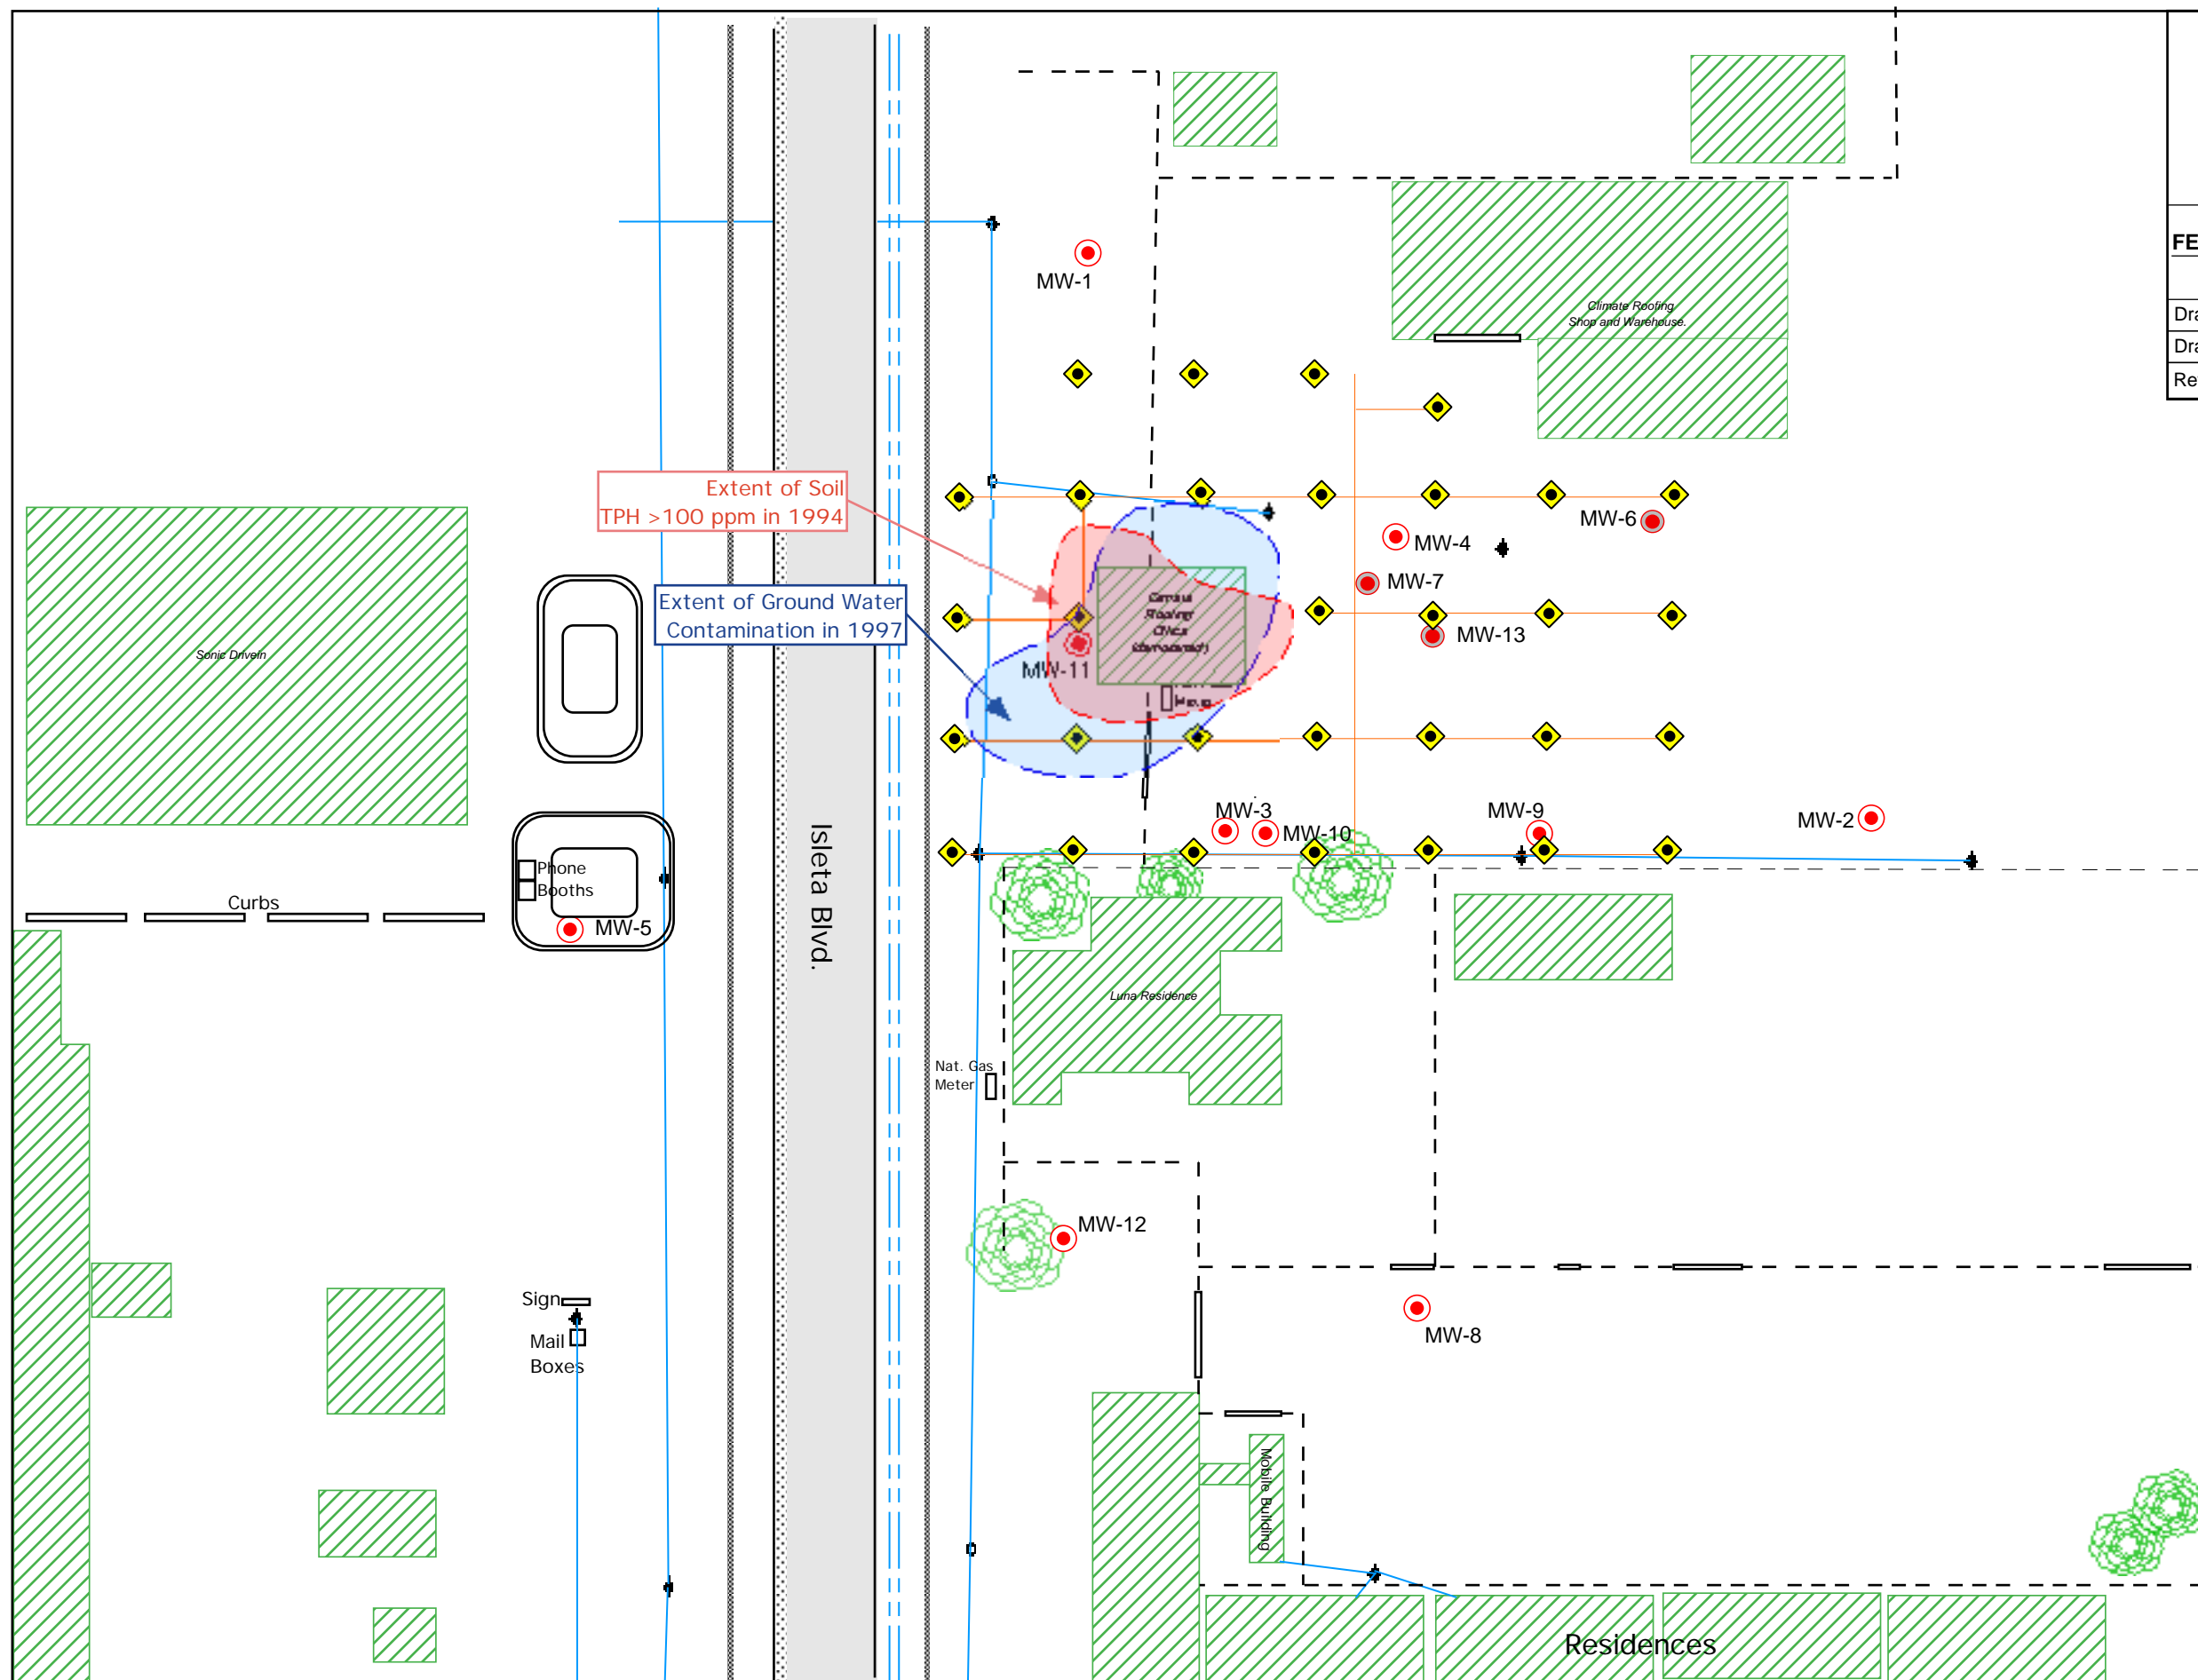
TECUMSEH PROFESSIONAL ASSOCIATES, INC.
Drawn by: WJB/CAF*	7/99	Client: BCEHD
Drafted by: SEF/CF	7/99	Project: 99-99-1190
Reviewed by: WJB/CF	7/99	Figure: 6A

- Hydrocarbon releases were first identified at this Site in 1990 during removal of the former USTs (see Figure 6A) under the direction of the Albuquerque Environmental Health Department. Based on limited laboratory analysis of soil samples, both gasoline and diesel fuels were released at the Climate Site.

- The Climate AS/VE system operated until June, 1996, during which time significant ground water hydrocarbon reductions were made. The final ground water benzene concentrations from June, 1996 and those collected subsequently by NMED/USTB are shown on Figure 6A. During March, 1994, soil test borings were completed to determine the degree of TPH reductions in the soil vadose zone. Results of those determinations are also shown on Figure 6A. This soil TPH extent is representative of soil conditions after 14 months of a total 40-month operational history, and do not represent the final cleanup levels. The hydrocarbon recovery curve (shown above) from the operational history of the AS/VE system at the Climate site shows approximately 4200 lbs. (700 gal.) of hydrocarbon were recovered via physical extraction. An unknown amount was also removed via enhanced in-situ biodegradation. NMED/USTB has conducted a limited amount of ground water sampling at the site since 1996, and the results indicate that BTEX levels have increased in monitor well MW-11. It is apparent from this data that the Site has experienced some “rebound” of BTEX and an unknown amount of soil contamination is still present.

Groundwater in all usable wells (ten existing wells) will be sampled during an initial event for organic parameters including BTEX, MTBE, EDC, EDB, and naphthalene using EPA Method 8260. It is believed that at least three of the existing wells, MW-6, 7 and 13 (see Figure 6A), were destroyed during building demolition. The following natural attenuation indicators will also be sampled for using field test kits: dissolved oxygen (DO), nitrate (NO₃), dissolved and total iron (Fe), alkalinity (HCO₃/CO₃), phosphate (PO₄), and sulfate (SO₄). Additional field tests will include pH, temperature, and conductivity. FEI/TPA will provide NMED/USTB and BCEHD 48-hour notification prior to initiating any sampling.
